REPORT ON ACCIDENT TO ANDHRA PRADESH GOVERNMENT BELL 430 HELICOPTER VT-APG AT RUDRAKODU HILLS IN KURNOOL DISTRICT OF ANDHRA PRADESH ON 02.09.2009

Type and Model	:	Bell 430
Nationality	:	Indian
Registration	:	VT-APG

c) Date of Accident : 02.09.2009

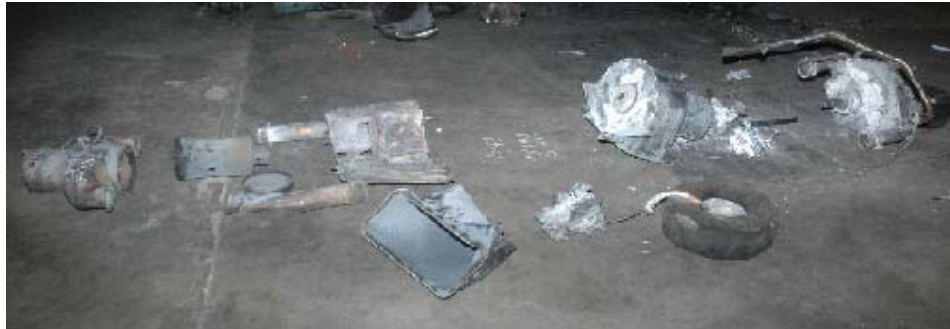
Dis-assembled view of Engine No.2

- a. **Combustion Chamber**
Liner displayed no sign of operational distress. Inlet vanes were in satisfactory condition. No elongation or crack seen in primary, secondary, tertiary holes. No distress, crack or metal deposit seen on the flame tube.
